SHORELINES – October 2011

Hurricane Irene

Beach Erosion

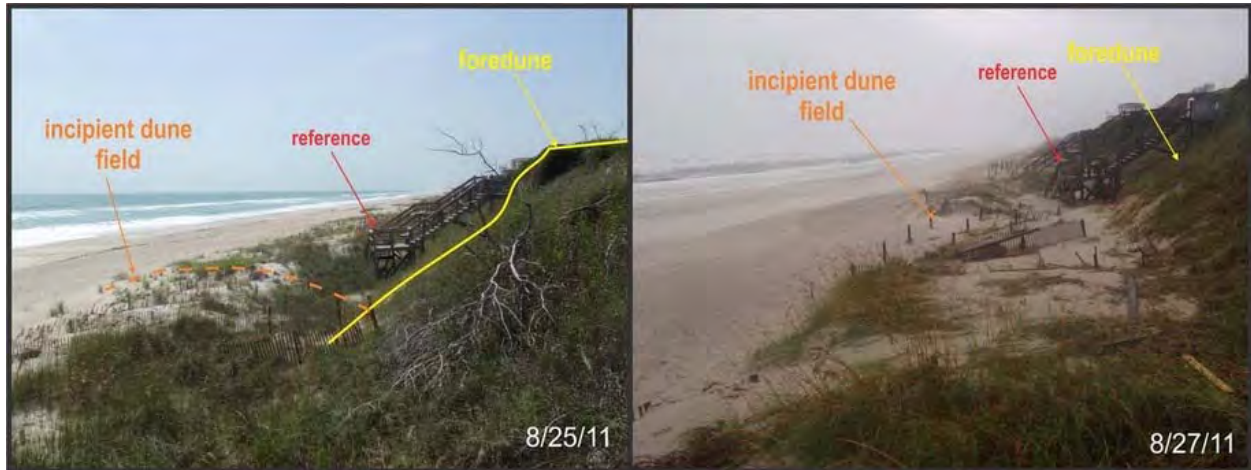
Erosion was not catastrophic but there was dune erosion along most of Bogue Banks, and figure 2 is a representative example of the type of dune erosion that occurred. The “old” existing high dunes (or emplaced foredune in east Emerald Isle) incurred no or very

little damage. However, the incipient dune field that has been created in the past several years with the aid of public/private sand fencing and planting did suffer noteworthy erosion.

Fig. 2 – “Before” (left panel) and “after” (right panel) from Memorial Park, Pine Knoll Shores. Notice the remaining sand fence posts and absence of sand and fencing slats between the posts on 8/27/11.

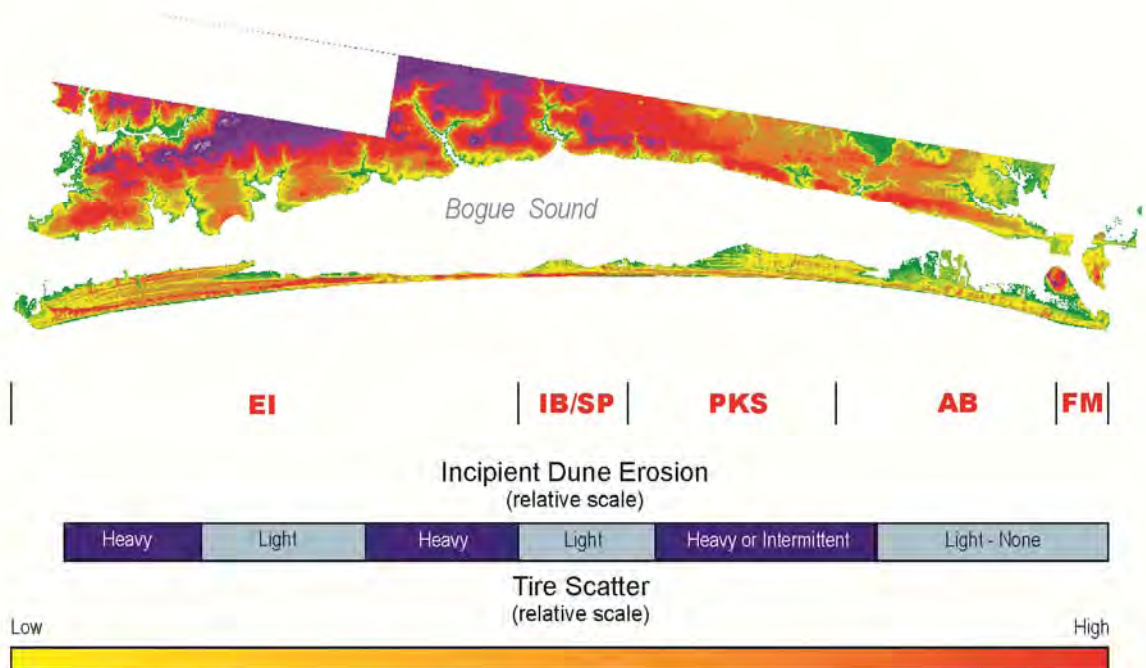
Importantly, the incipient dune field has acted as a line of defense for that large foredune fronting most of Bogue Banks and often exceeds an elevation of 20 feet. The geographic extent of incipient dune erosion and was very “zonal” across Bogue Banks and figure 3 loosely depicts the different areas of severity along the island. Please keep in mind this is a very subjective exercise, but provides a sense (order of magnitude) of the erosion. Figure 4 is an example of “worse case” erosion.

Fig. 3 – Map depicting the relative scale of incipient dune damage and tire scatter along Bogue Banks. EI – Emerald Isle, IB/SP – Indian Beach/Salter Path, PKS – Pine Knoll Shores, AB – Atlantic Beach, and FM – Fort Macon.

Tire Scatter – As also depicted on Figure 3, tires and to a much, much lesser extent concrete pipes from offshore artificial reefs were brought to the beach compliments of *Irene*. The tire scatter was “heavy” in Atlantic Beach, but quickly subsided to “light” in Pine Knoll Shores, “very light” in Indian Beach, to “almost nonexistent” in Emerald Isle. The N.C. Division of Marine Fisheries collected the debris from the beach within days of *Irene*’s departure.

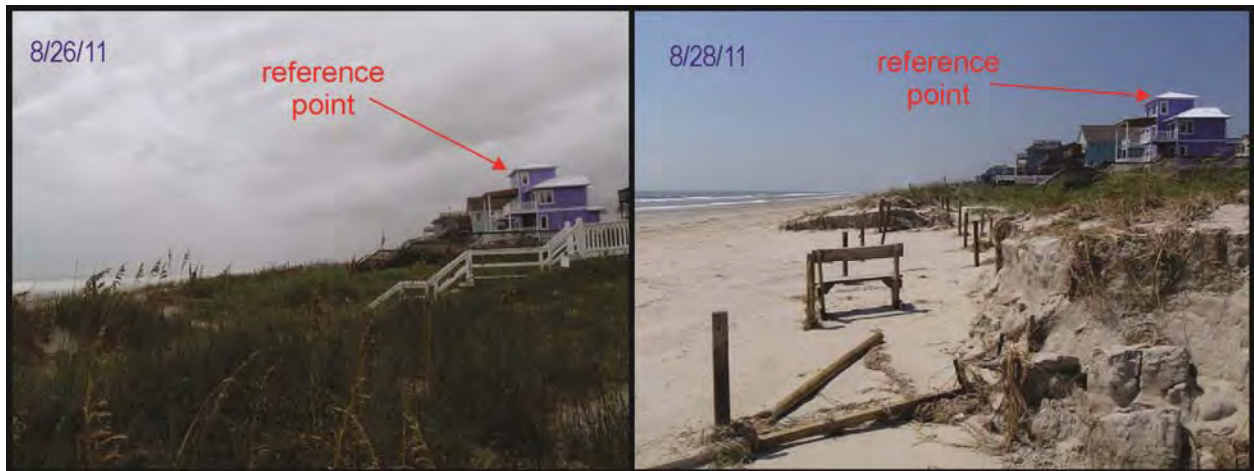
Fig. 4 – Before (8/26/11) and after (8/28/11) incipient dune impacts of *Irene* at Ocean Oaks, Emerald Isle.

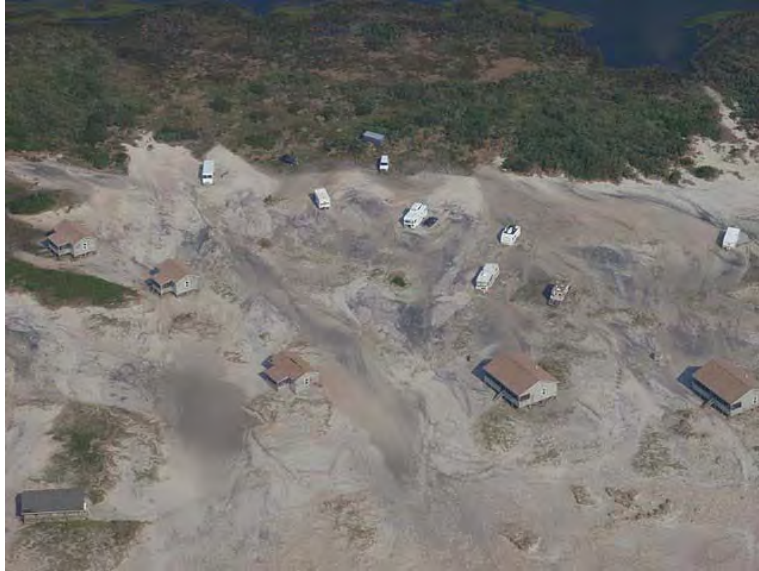
Shackleford Banks and Core Banks – Although outside our purview, a series of aerial photographs obtained two days after *Irene* passed do allow us to make some casual observations concerning the Cape Lookout Seashore and moving north to south; (a) South Core Banks – there was a high degree of overwash along this region with what appears to be heavy damage sustained by some of the cabins, RVs, and other structures (Fig. 5). No new inlets formed. (b) Cape Lookout – the lighthouse is still standing and damages to the ancillary structures in this area appeared to minor and wind related. (c) Shackleford Banks – no overwash occurred that crossed the entire island. There is a narrow spot located along the eastern edge of this island (almost due north of the Lookout spit) that would be prone to this.

Fig. 5 – Aerial photograph depicting overwash sand impacting cabins and RVs at south Core Banks, Cape Lookout National Seashore.
