Preliminary Assessment
IRENE UPDATE #4 (8/27/11)

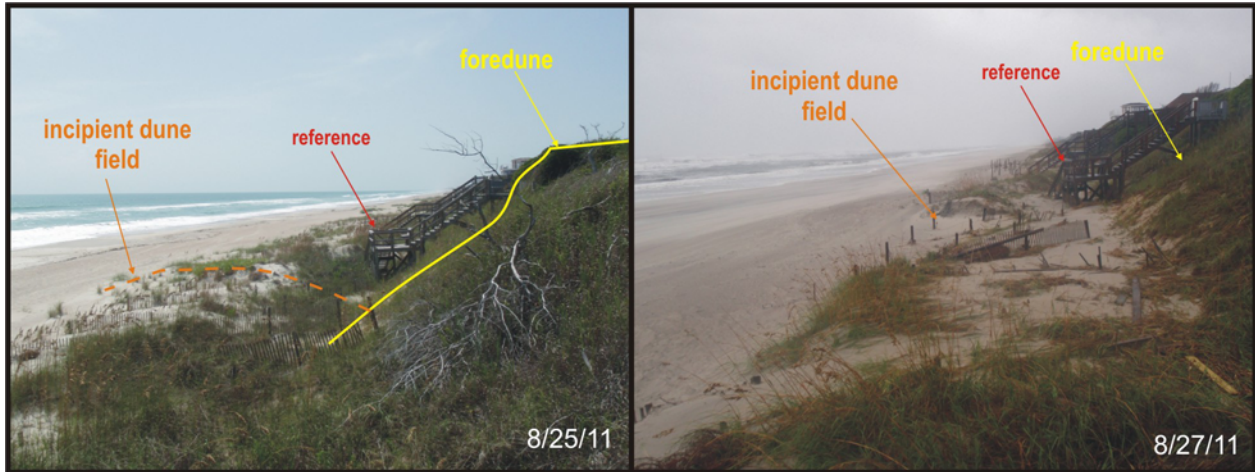
Erosion was not catastrophic but there was dune erosion along most of Bogue Banks, and figure 2 is a representative example of the type of dune erosion that occurred. The “old” existing high dunes (or emplaced foredune in east Emerald Isle) incurred no or very little damage. However, the incipient dune field that has been created in the past several years with the aid of public/private sand fencing and planting did suffer noteworthy erosion. In some places it was simply worse than others (see figure 3 and 4). Making any precise assessments concerning berm erosion (flat part of the beach) will be difficult until our survey is completed. In general however, much of the sand that was removed from the upper part of the beach tends to be translated offshore in bar configurations, which creates a very “flat” looking beach immediately after the storm. Some of this sand will accrete back onto the beach – some will not, and again, our repetitive surveys help us catalogue the volume and location of sand along the beach profile.

Fig. 2 – “Before” (left panel) and “after” (right panel) from Memorial Park, Pine Knoll Shores. Notice the remaining sand fence posts and absence of sand and fencing slats between the posts on 8/27/11.

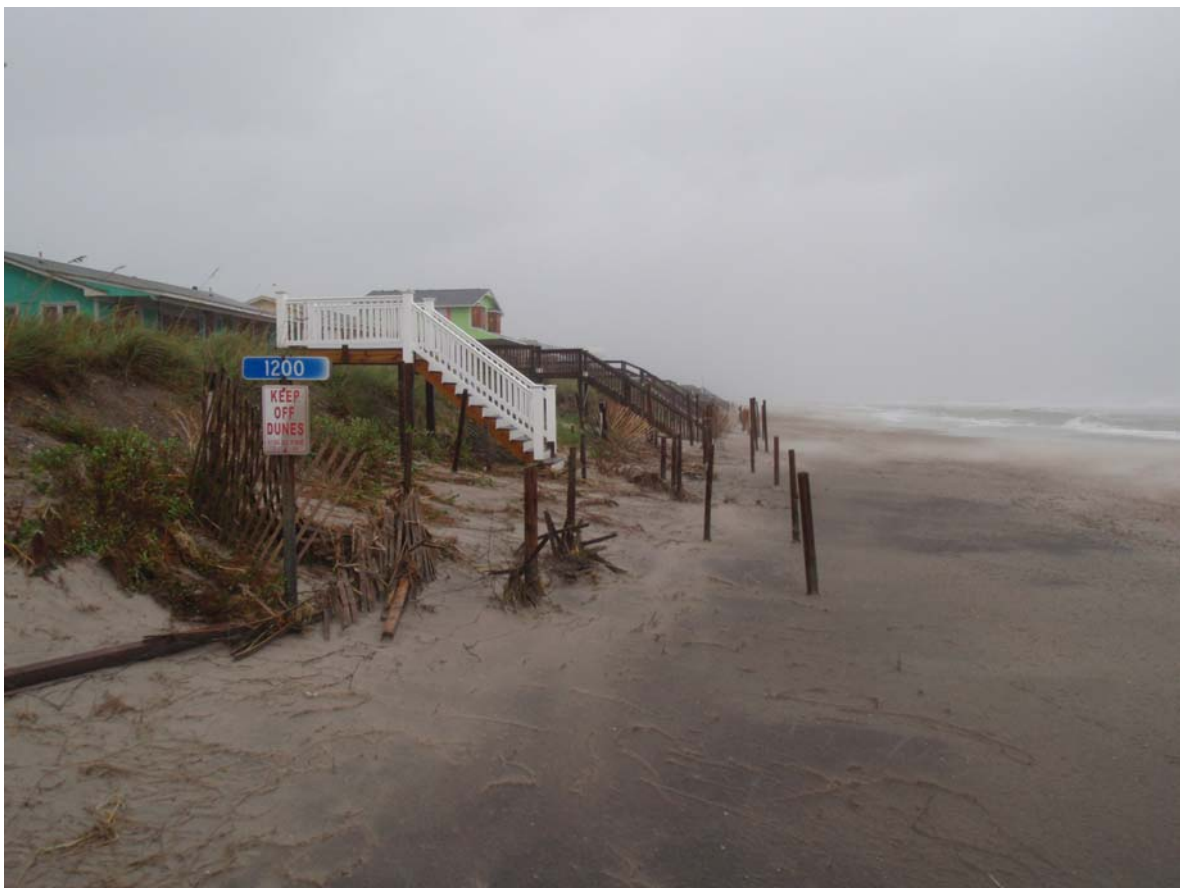
Fig. 3 – 12th Street, Emerald Isle looking east – “worse” incipient dune erosion.

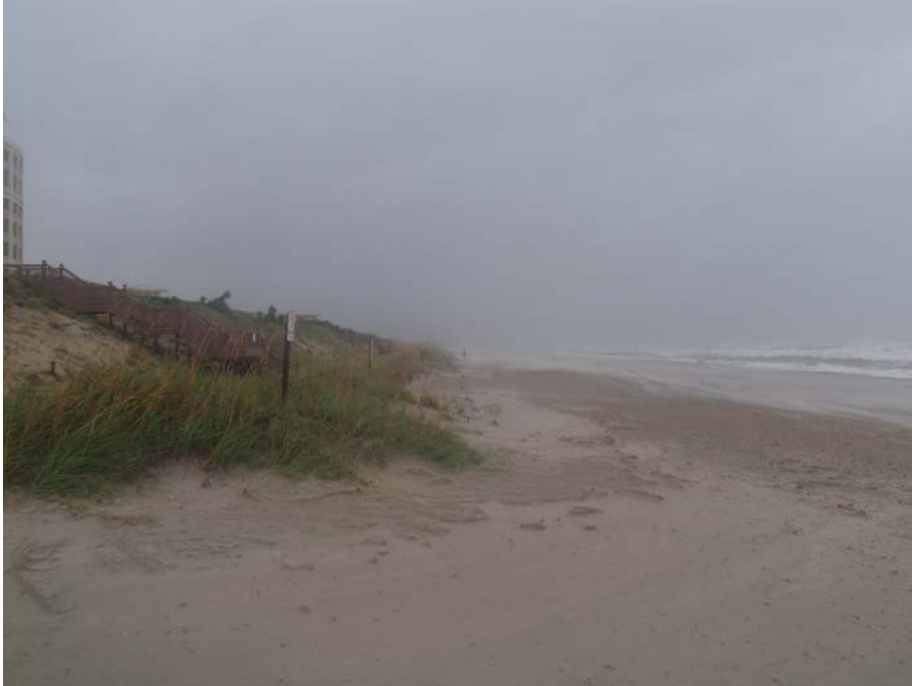
Fig. 4 – Indian Beach 4WD Ramp, looking east – almost no incipient dune erosion.

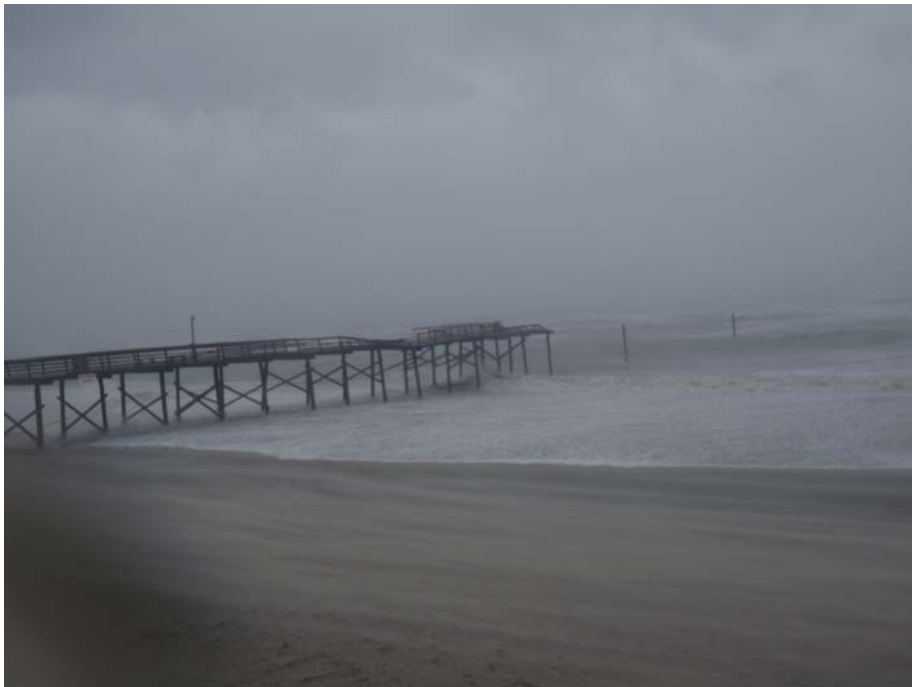
In closing, we will provide more information concerning wave heights and other physical parameters soon. Sea conditions; besides causing beach erosion, also caused damage to the piers along Bogue Banks as widely reported in the media (Fig.5)

Fig. 5 – Sheraton fishing pier (8/27/11).
