IRENE UPDATE #5 (8/30/11)

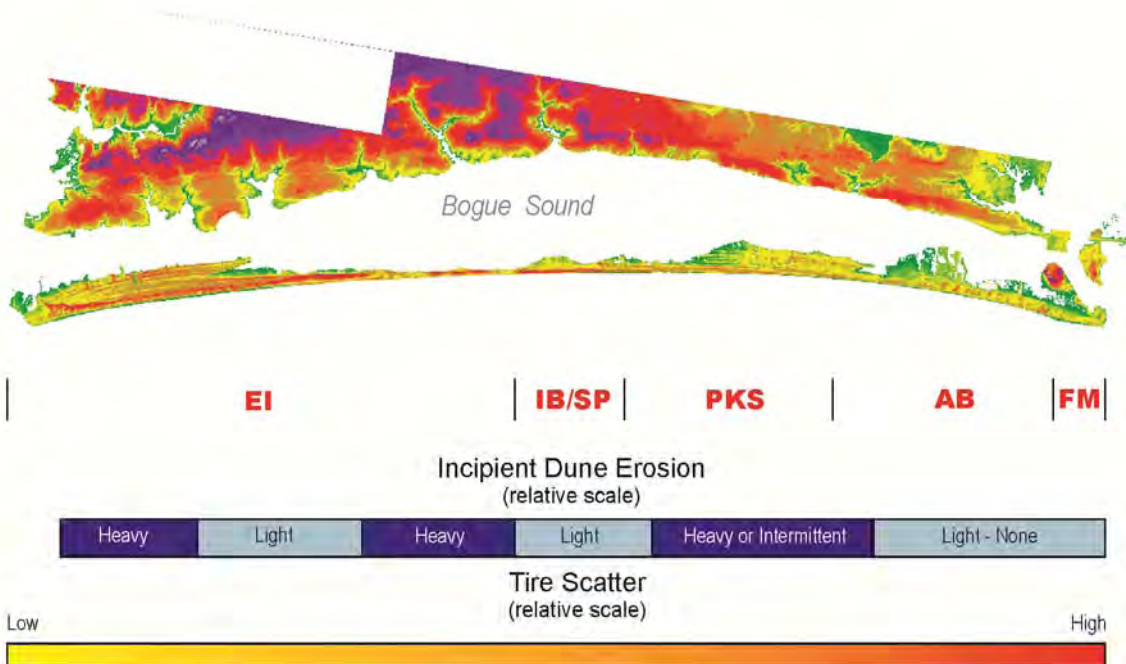
Fig. 1 – Map depicting the relative scale of incipient dune damage and tire scatter along Bogue Banks. EI – Emerald Isle, IB/SP – Indian Beach/Salter Path, PKS – Pine Knoll Shores, AB – Atlantic Beach, and FM – Fort Macon.

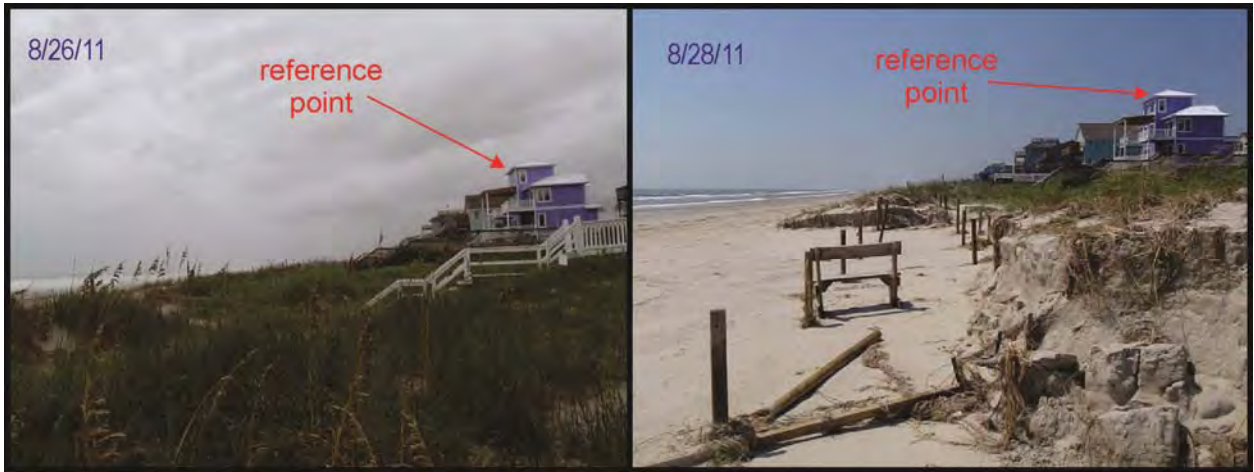
Fig. 2 – Before (8/26/11) and after (8/28/11) incipient dune impacts of *Irene* at Ocean Oaks, Emerald Isle.

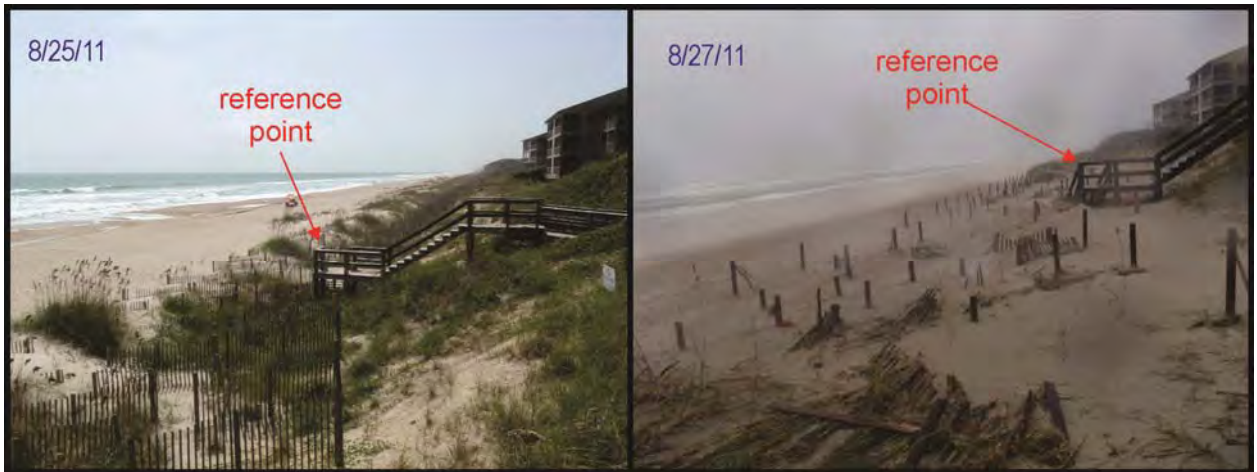
Fig. 3 – Before (8/25/11) and after (8/27/11) incipient dune impacts of *Irene* at the Clamdigger, Pine Knoll Shores.

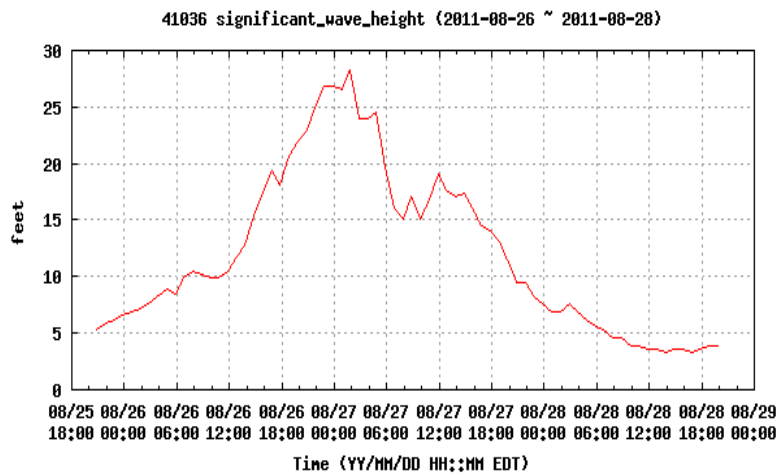
Waves and Tides – Significant wave heights exceeded 25 feet at buoy [41036](#) located 40 miles due south of Beaufort Inlet (Fig. 4) and water levels were 3 feet higher than “normal” at [Beaufort Inlet](#) tide gauge.

Fig. 4 - Significant wave heights from August 26th through the 28th recorded by ocean buoy 41036, located roughly 40 miles due south of Beaufort Inlet.

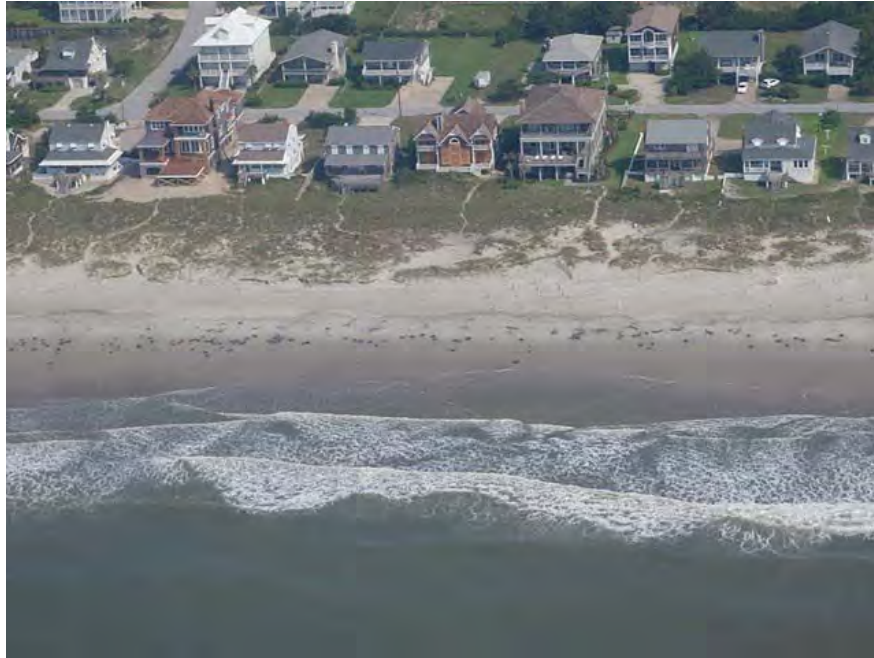
Tire Scatter – As depicted on Figure 1, tires and to a much, much lesser extent concrete pipes from offshore artificial reefs were brought to the beach compliments of *Irene*. The tire scatter was “heavy” in Atlantic Beach (Fig. 5), but quickly subsided to “light” in Pine Knoll Shores, “very light” in Indian Beach, to “almost nonexistent” in Emerald Isle. The N.C. Division of Marine Fisheries begun collecting the debris from the beach yesterday – [press release](#).

Fig. 4 – Tire scatter along Atlantic Beach.
